PROPERTY INSPECTION REPORT

KBM Home Inspect LLC
License #: 3380000867
Inspector: Logan Melton

Champ de Mars, 5 Av. Anatole France, 75007, Paris, France

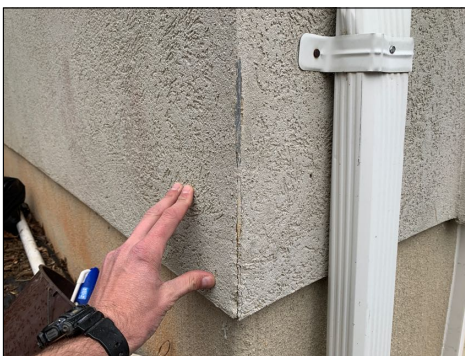
Damage and evidence of moisture intrusion was observed in several locations around the exterior of the home (See Photos for Locations). Affected areas will be prone to moisture intrusion and subsequent damage. I recommend evaluation and repair as needed by a qualified contractor that is familiar with the EIFS system. (\$2500-\$5000+)

Crack at Corner (Rear of Garage)

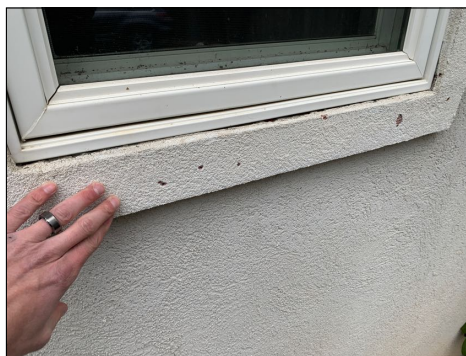
Damage Observed (Forward of Garage Doors)

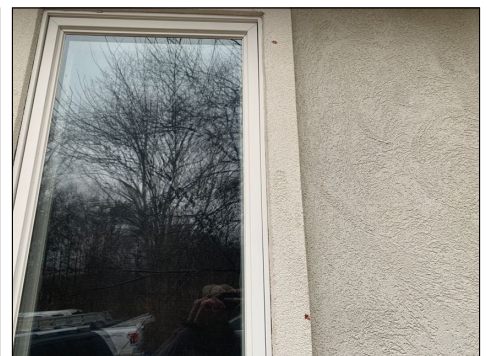
Damage Observed (Forward of Garage Doors)

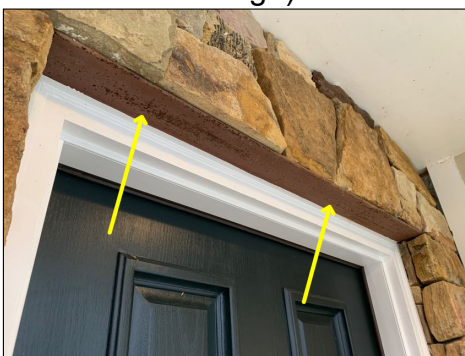
The lintels around the home were rusted. Lintels are steel supports above the windows and doors. Rusting lintels can damage the brick siding. I recommend having the lintels treated and sealed.

Rusted Lintel

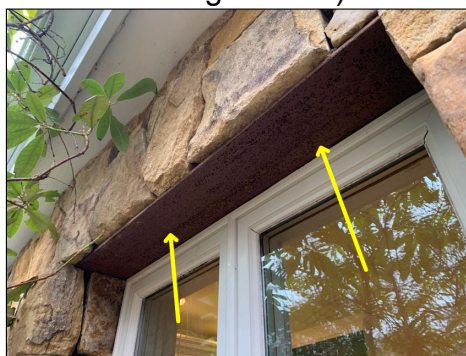
Rusted Lintel

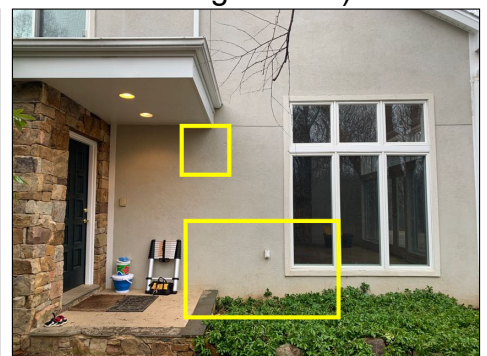
Evidence of Moisture Intrusion Observed Here

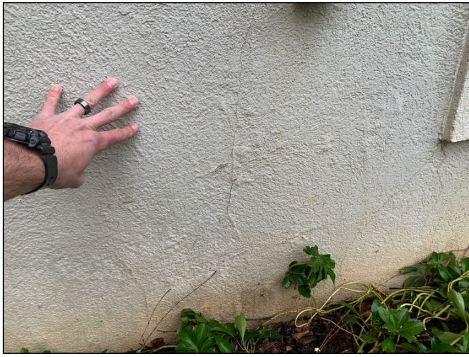
Cracks/Spalling Observed (Near Front Door)

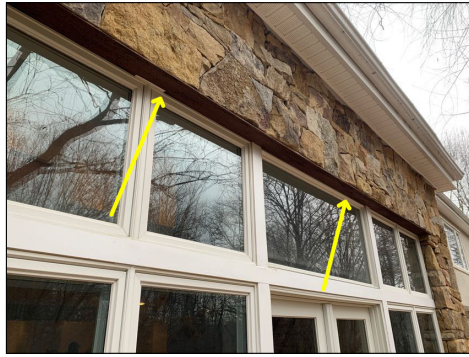
Rusted Lintel

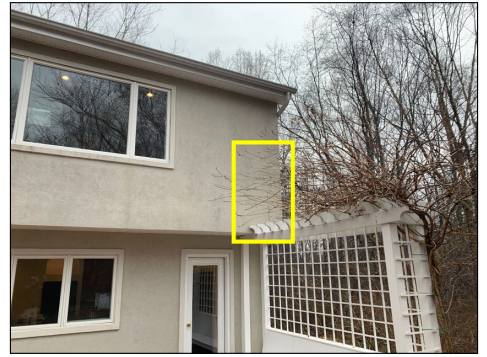
Damage to Siding Observed Here

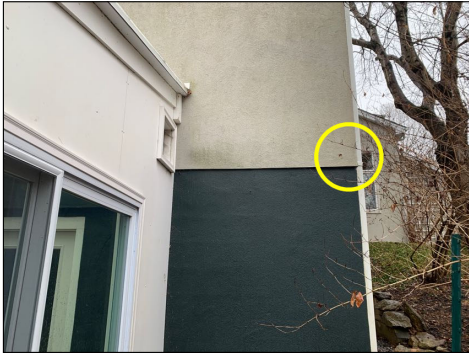
Damage to Siding Observed Here

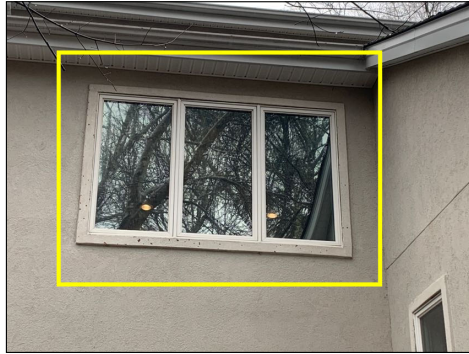
Damage to Siding Observed at This Window

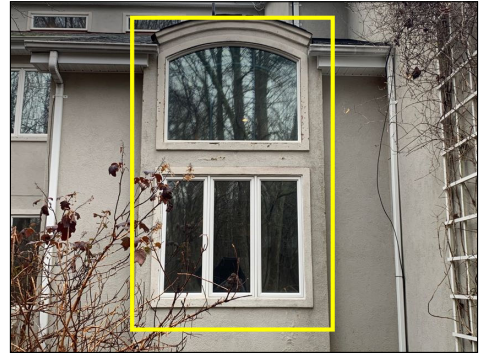
Damage to Siding Observed Around These Windows (Rear of Home)

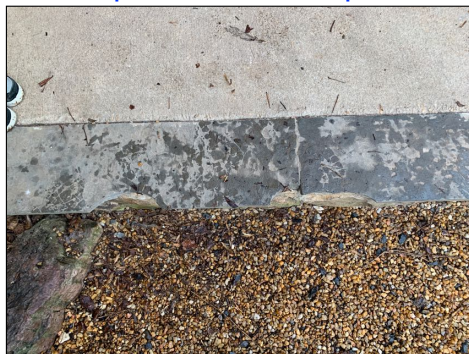
There was some damage to the slate step at the front steps. Have repaired as desired.

Damage Observed at Front Steps

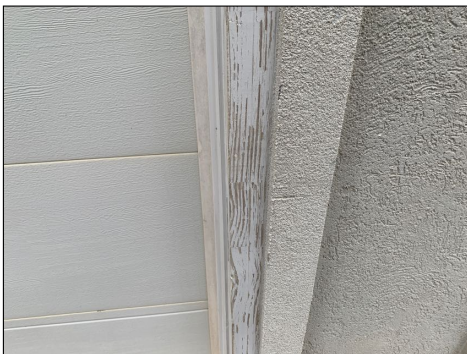
Peeling paint was observed at some of the wood trim around the exterior of the home. Paint protects the wood from the elements. I recommend having this corrected. This is a normal part of home maintenance.

Peeling Paint Observed
(Representative Photo)

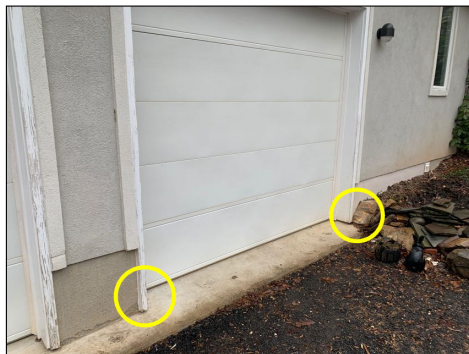
Rot was observed in a few locations at the exterior trim (See Photos for Locations). I recommend repair by a qualified contractor. (\$150-\$300+)

Rot Observed Here

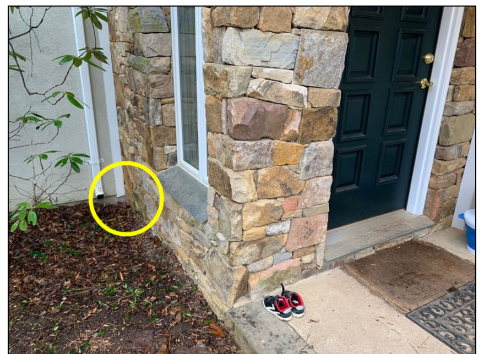
Rot Observed Here

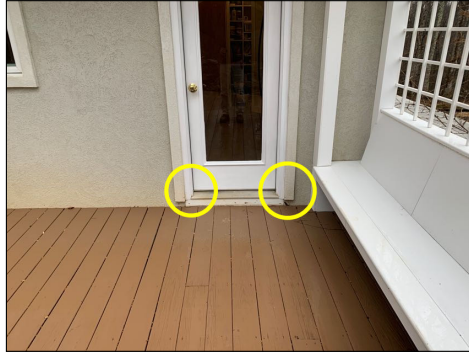
Rot Observed Here

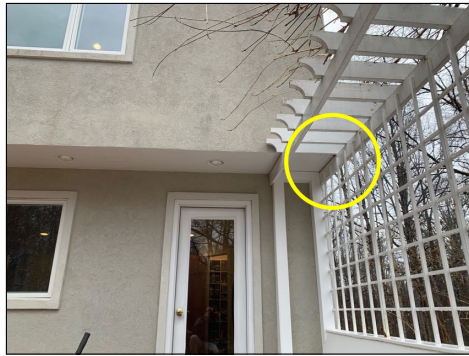
Rot was observed in the eaves at the front of the home. I recommend repair by a qualified contractor. (\$100-\$200+)

Rot in Soffit Observed Here

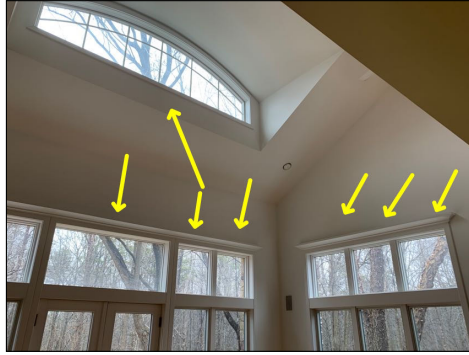
There were seven (7) windows throughout the home that had condensation between the panes (See Photos). This occurs when the interior seal fails, and allows condensation to form. I recommend repair/replacement by a qualified contractor. (\$500+ per window)

These Windows in the Living Room had Condensation Between the Panes

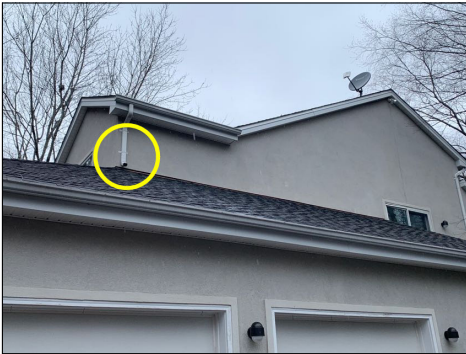
Several of the downspouts terminated above the shingles. This is a common practice, but can affect the lifespan of the shingles they discharge onto. You may wish to extend the downspouts to the ground, or a lower gutter.

Downspout Terminating Above Roof

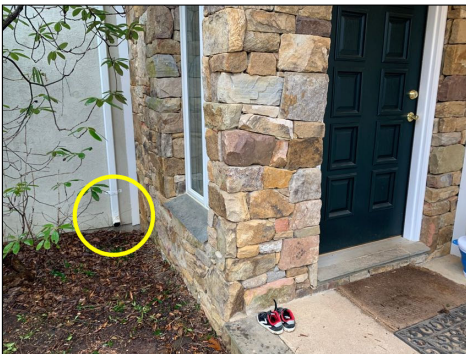
A few of the downspouts terminated too close to the foundation. This can concentrate roof drainage around the foundation. I recommend extending the downspouts at least six feet from the foundation.

Downspout Terminating too Close to Foundation

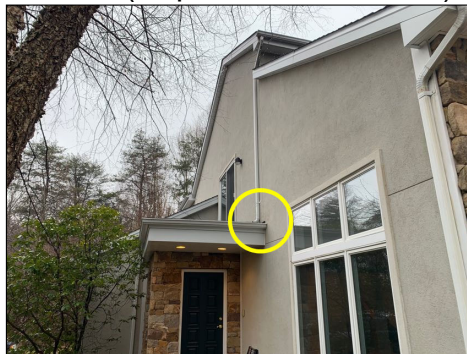
Downspout Terminating Above Roof

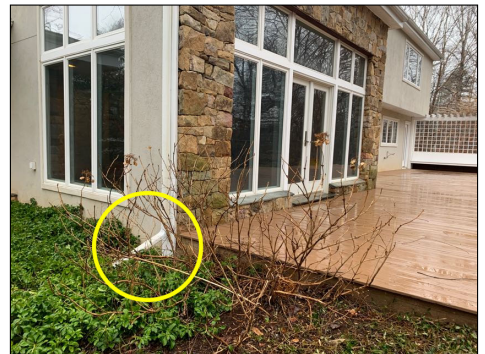
Downspout Terminating too Close to Foundation

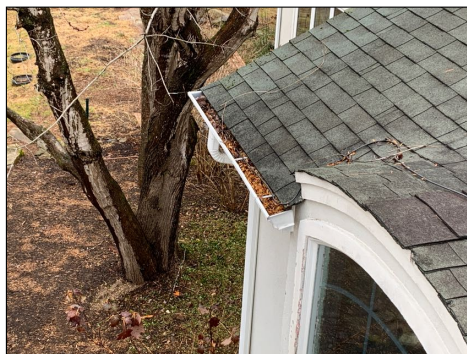
The gutters around the home were full of debris. This will affect the performance of the roof drainage system. I recommend having the gutters cleaned. This is a normal part of home maintenance.

Gutters Full of Debris (Representative Photo)

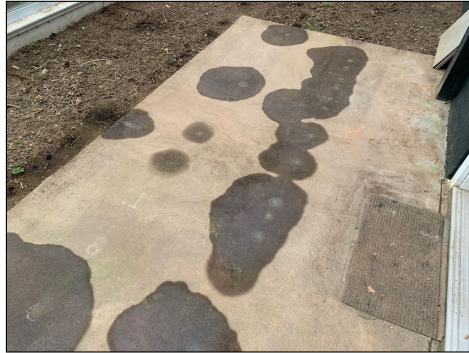
The roof above the solarium was leaking at the time of inspection. I recommend repair by a qualified contractor. (\$400-\$800+)

Leaks Observed in Solarium

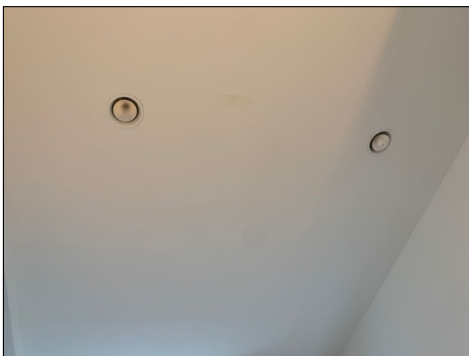
A moisture stain was observed above the stairs to the second floor. This indicates previous moisture intrusion. The stain appeared dry, but I was unable to test for moisture content. I recommend repair as needed by a qualified roofer. (\$250-\$500+)

Moisture Staining Above Stairs

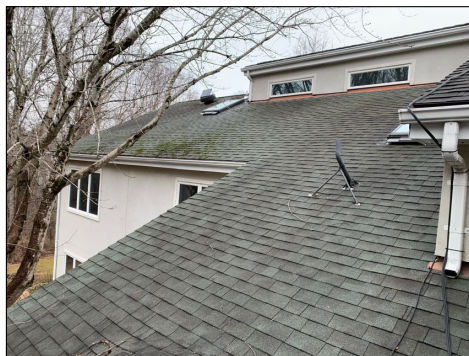
There was some moss growing on the roof. This condition is typically cosmetic and does not affect the roof's ability to shed water. You may wish to have the moss cleaned off.

General Photo/Moss Observed

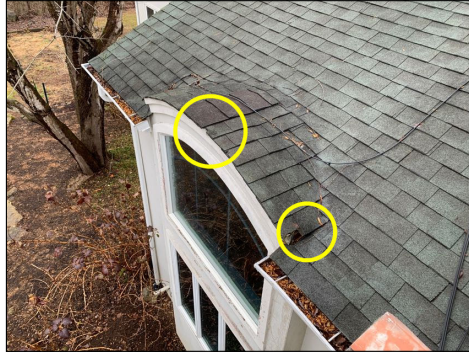
There was some damage to the roofing at the rear of the home. I recommend repair by a qualified roofer. (\$200-\$400+)

Damage Observed

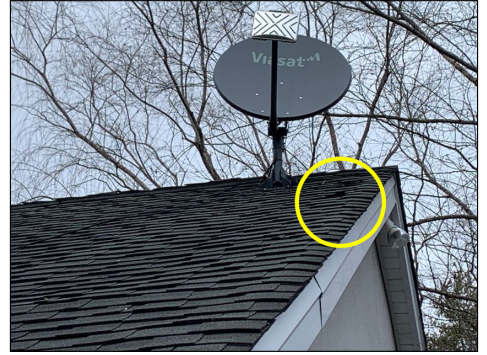
Some nail pops were observed throughout the roofing. Nail pops leave the shingle above prone to wind damage. Nail pops can also damage the shingle above. I recommend repair by a qualified roofer. (\$100-\$200+)

Nail Pop Observed

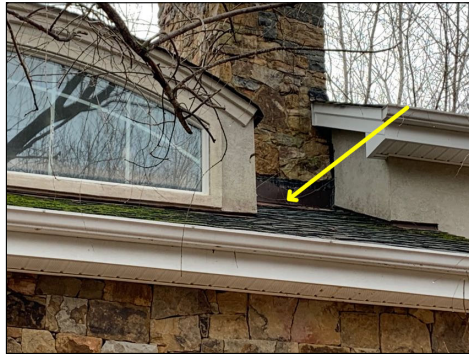
There was a noticeable dip in the roof covering materials at the front of the home (See Photo). This indicates moisture intrusion and likely rot beneath. I recommend repair as needed by a qualified roofer. (\$500-\$1200+)

Evidence of Leak Observed Here

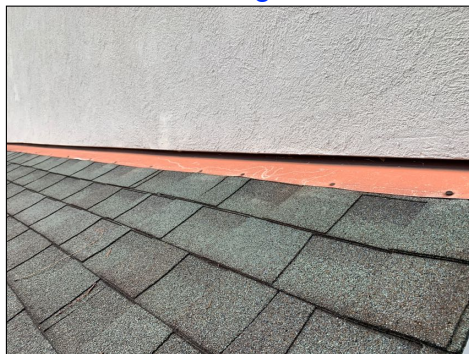
There were exposed nail heads observed at the headwall flashing at the of the home. Exposed nails can rust and cause leaks. I recommend having the nails sealed.

Exposed Nails Observed

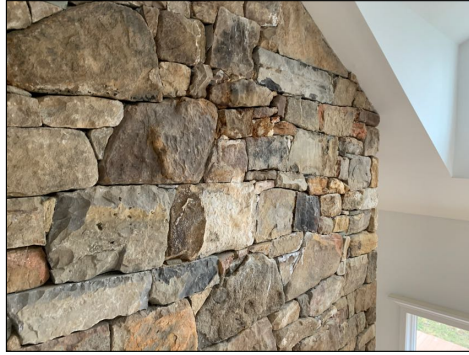
Efflorescence was observed at the interior of the chimney. This indicates moisture intrusion, and likely a flashing/chimney crown issue. I recommend repair as needed by a qualified roofer. (\$300-\$600+)

Efflorescence Observed

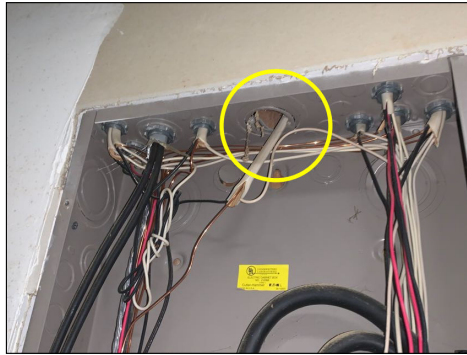
There was a cable coming through the main panel enclosure that was missing an approved bushing or clamp. This can allow the cable to rub against the sharp edges of the panel and cause damage. I recommend repair by a qualified electrician. (\$100+)

Missing Clamp/Bushing

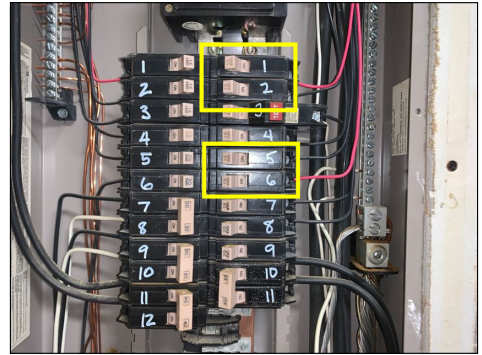
The multi-wire branch circuit(s) did not have an approved handle tie. Because the two energized wires of a multi-wire branch circuit share the same neutral wire, these breakers are required to be tied. It would be prudent to have this corrected.

MWBC's not Tied

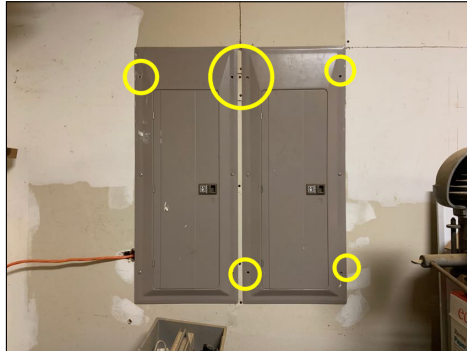
Both of the dead fronts at the main electrical panels were missing screws. I recommend having approved screws installed.

Missing Screws

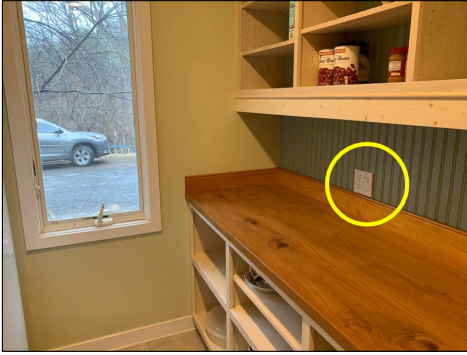
There was an outlet with a reversed polarity (hot and neutral reversed) in the utility room. I recommend repair by a qualified electrician. (\$100+)

This Outlet in the Utility Room had a Reversed Polarity Reading

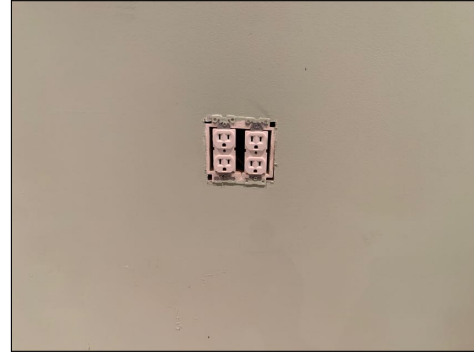
There were several outlets missing cover plates in the basement. I recommend having cover plates installed.

Missing Cover Plates in Basement (Representative Photo)

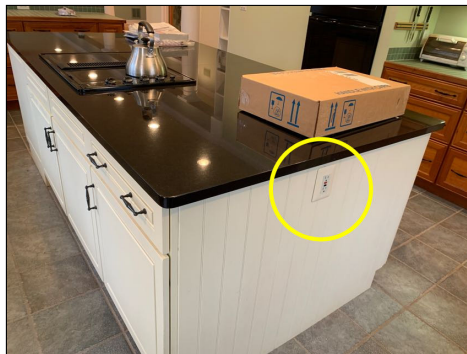
The GFCI device at the kitchen island did not trip when tested. This is a safety concern. I recommend repair by a qualified electrician. (\$150-\$300+)

This GFCI Device did not Trip when Tested

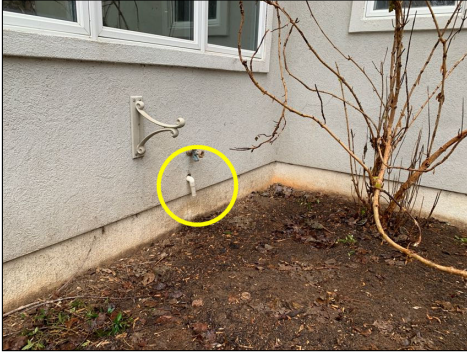
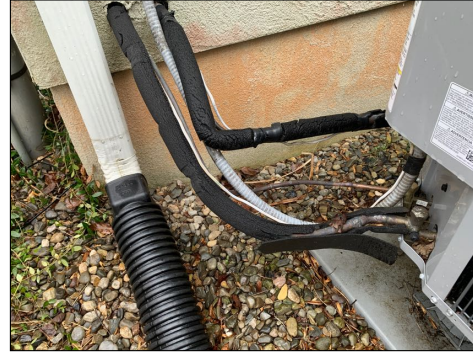
The insulation for the refrigerant lines was missing or damaged. I recommend having this corrected.

The condensate drain line(s) terminated too closely to the foundation. This can concentrate water around the foundation. I recommend having them extended further away from the foundation.

Condensate Drain Line too Close to Foundation Damaged/Missing Insulation at Refrigerant Lines

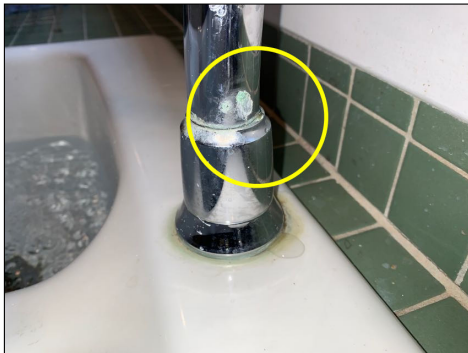
The kitchen sink faucet leaked at the time of inspection. I recommend repair by a qualified plumber. (\$100+)

Leak at Kitchen Sink Faucet

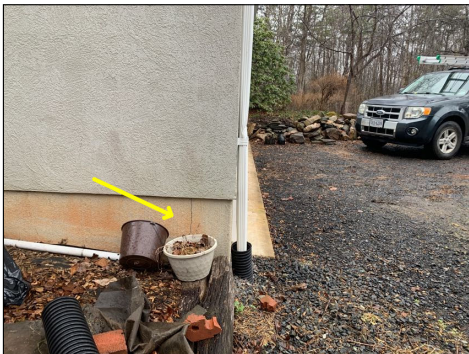
There was typical cracking observed in the foundation walls. These cracks are common and do not represent structural issues. I recommend having them patched to prevent moisture and pest intrusion.

Typical Crack Observed

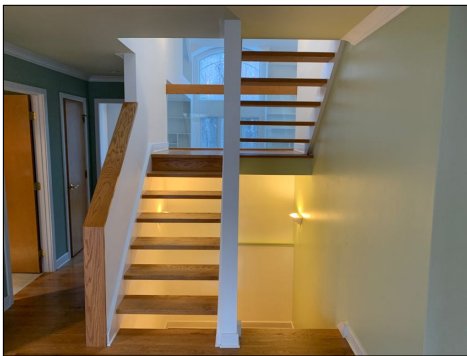
FYI: The stairs in the home had open riser spaces. This was likely acceptable when the home was built, but would be a safety concern by today's standards. Have repaired as desired.

Open Risers Observed

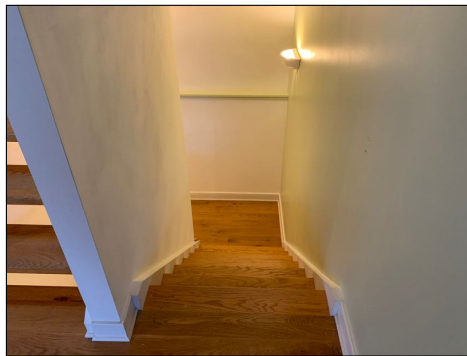
The stairs to the basement were missing handrails at both sections. This is a safety concern. I recommend repair by a qualified contractor. (\$200-\$400+)

Missing Handrail

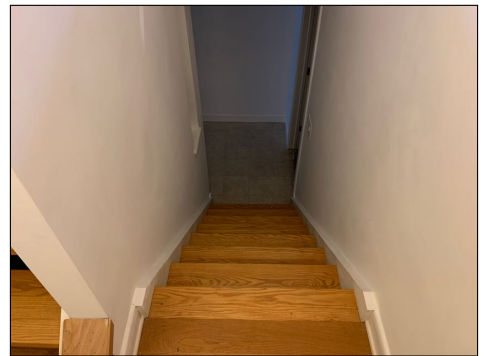
Missing Handrail
