# PROPERTY INSPECTION REPORT

**KBM Home Inspect LLC**  
**License #: 3380000867**  
**Inspector: Logan Melton**

123 Main St, Richmond, Va, 23222

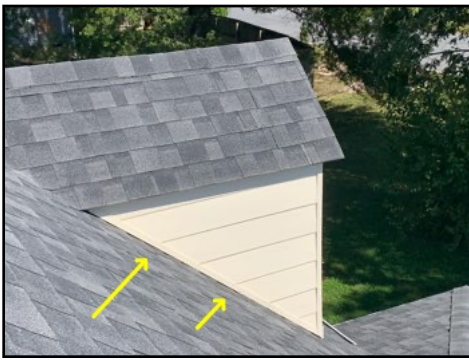
The vinyl siding was in contact with the roofing materials. The roofing can get very hot in warmer months, and can sometimes cause warping or damage to the siding. It would be prudent to monitor this condition, and take corrective action if needed.

Example of Vinyl in Contact with Roof

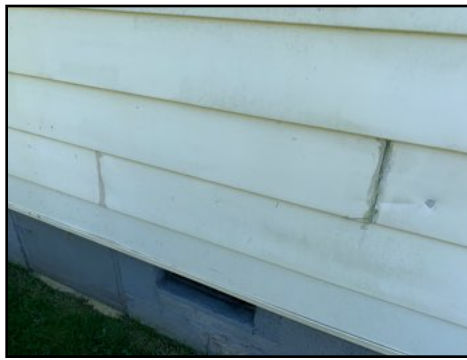
Some caulking and inadequate sidelap was observed at the vinyl siding at the left side of the home. This indicates a previous repair. I recommend having this repaired as needed by a qualified contractor. (\$100-\$200+)

Caulking/Inadequate Sidelap

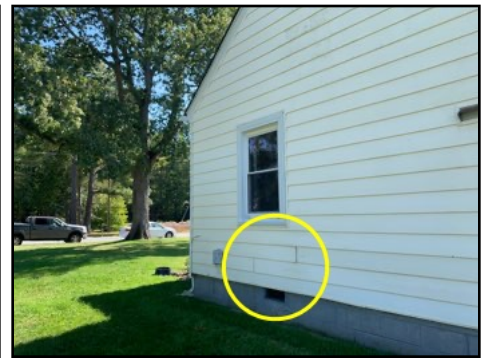
Caulking/Inadequate Sidelap Observed Here

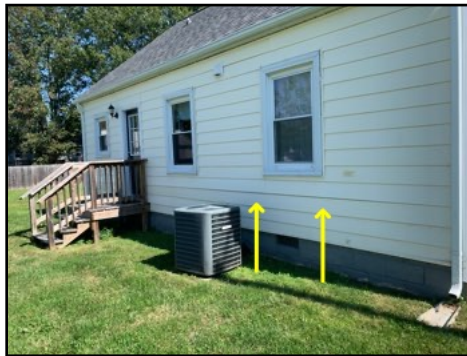
Some loose siding was observed near the condensing unit for the HVAC system. I recommend repair by a qualified contractor. (\$100+)

Loose Siding Observed Here

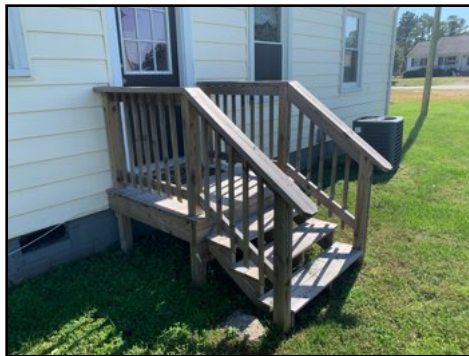
The rear steps should be sealed to prolong the life of the materials.

The posts at the rear steps were in contact with ground soil. You should monitor these areas for rot.

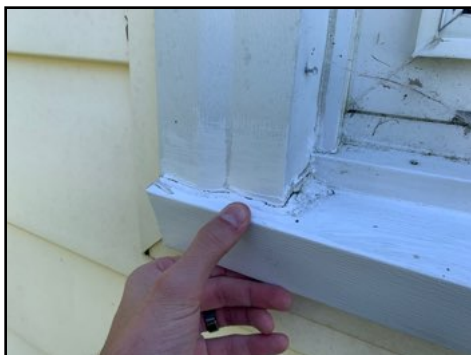
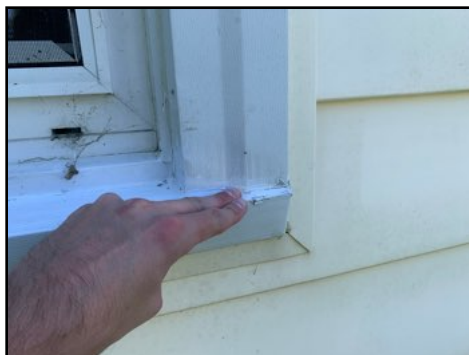
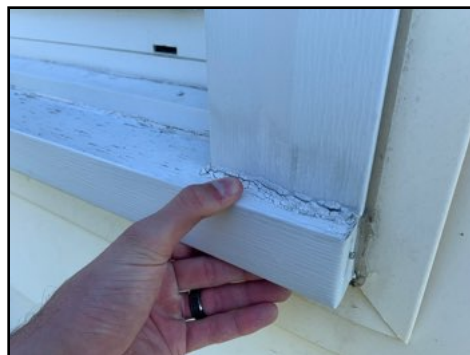
There was some dry and cracking caulk observed in several areas around the exterior of the home. Caulk prevents moisture and wind intrusion. I recommend replacing any cracked/missing caulk. This is a normal part of home maintenance.

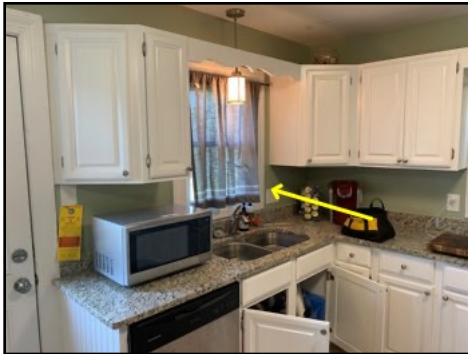
There were two windows throughout the home that had condensation between the panes (See Photos). This occurs when the interior seal fails, and allows condensation to form. I recommend repair/replacement by a qualified contractor. (\$250-\$500+ per window)

The Lower Sash of this Window in the Kitchen has Condensation Between the Panes

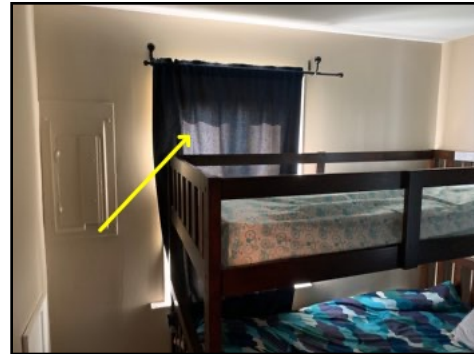
The Upper Sash of this Window in the Downstairs Rear Right Bedroom has Condensation Between the Panes

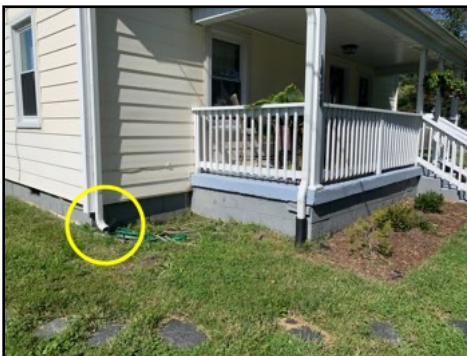
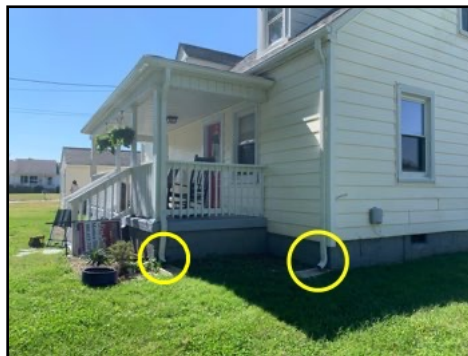
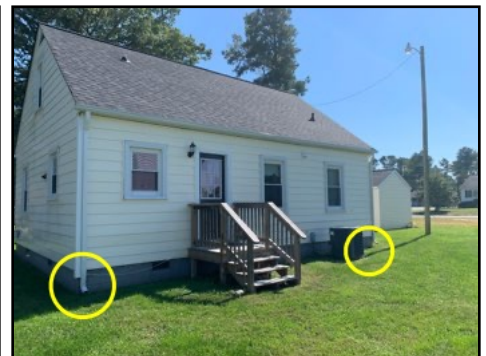
The downspouts terminated too close to the foundation. This can concentrate roof drainage around the foundation. I recommend extending the downspouts at least six feet from the foundation. (\$100+)

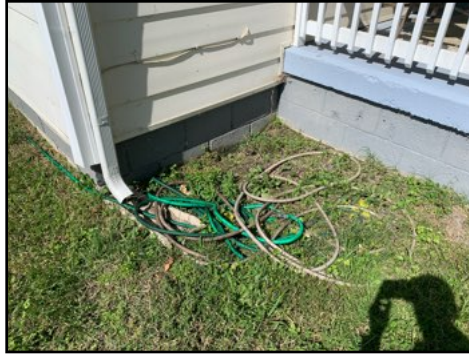
There were a few low areas around the exterior of the home. I recommend having an appropriate slope created away from the home to prevent ponding water.

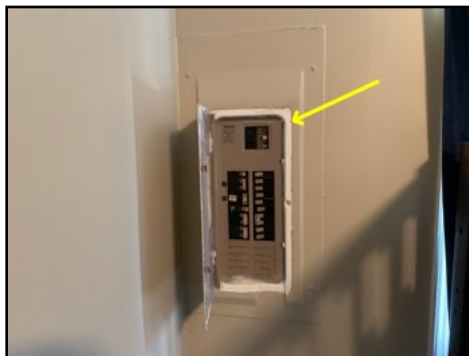
The dead front at the main electrical panel was caulked and painted to the wall, and was not removed to prevent damage. Although no deficiencies were observed, it is possible that hidden defects exist that were not observed.

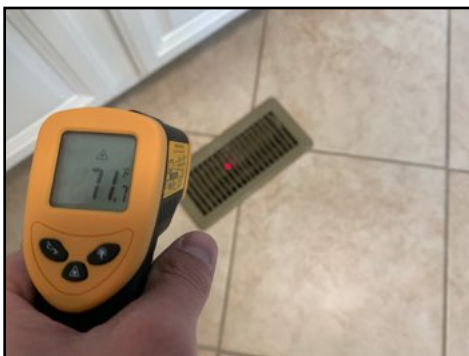
The supplemental emergency heat did not respond to the thermostat when tested. The fan was on, but no heat was being produced. I recommend repair by a qualified HVAC contractor. (\$200-\$400+)

Emergency Heat not Operating Properly

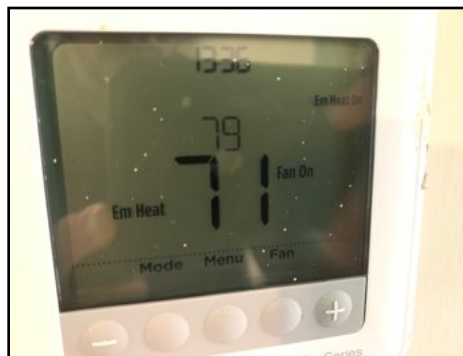
Thermostat set to Emergency Heat

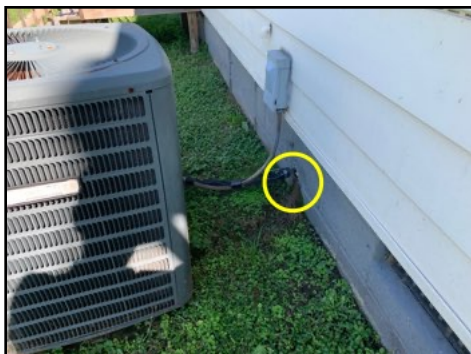
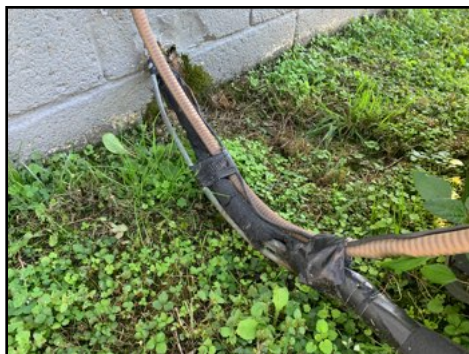
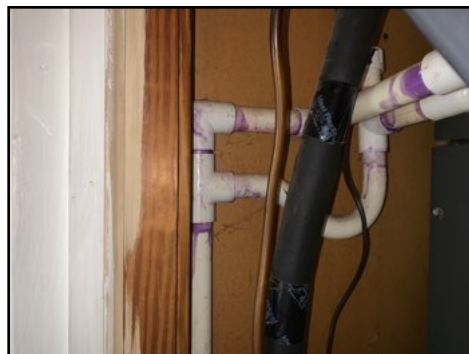
The condensate drain line(s) terminated too closely to the foundation. This can concentrate water around the foundation. I recommend having them extended further away from the foundation.

The insulation for the refrigerant lines was missing or damaged. I recommend having this corrected. (\$25+)

The primary and secondary condensate drain lines were plumbed together. These lines should be plumbed independently of each other. I recommend repair by a qualified HVAC contractor. (\$150-\$300+)

The air handler under the stairs did not have a drain pan under it. This protects the materials below. I recommend having a qualified HVAC contractor install a drain pan. (\$200-\$400+)

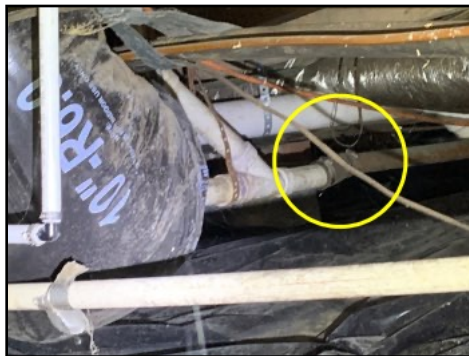
There was a connection between PVC waste piping and copper waste piping that had negative slope. This can trap waste water in the low area. I recommend repair by a qualified plumber. (\$100-\$200+)

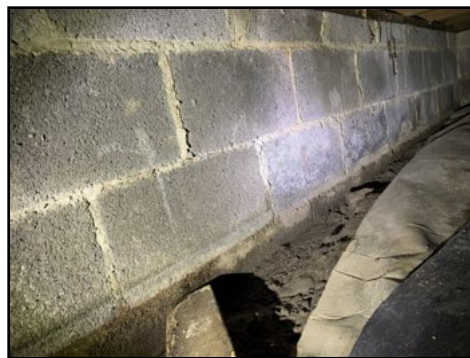
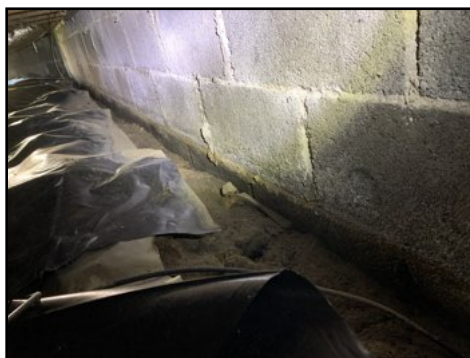
Evidence of standing water was observed at the perimeter of the crawlspace. This indicates ground water intrusion into the crawlspace. This can cause fungus and damage to the structure above. See General Structure Section for Recommendations.

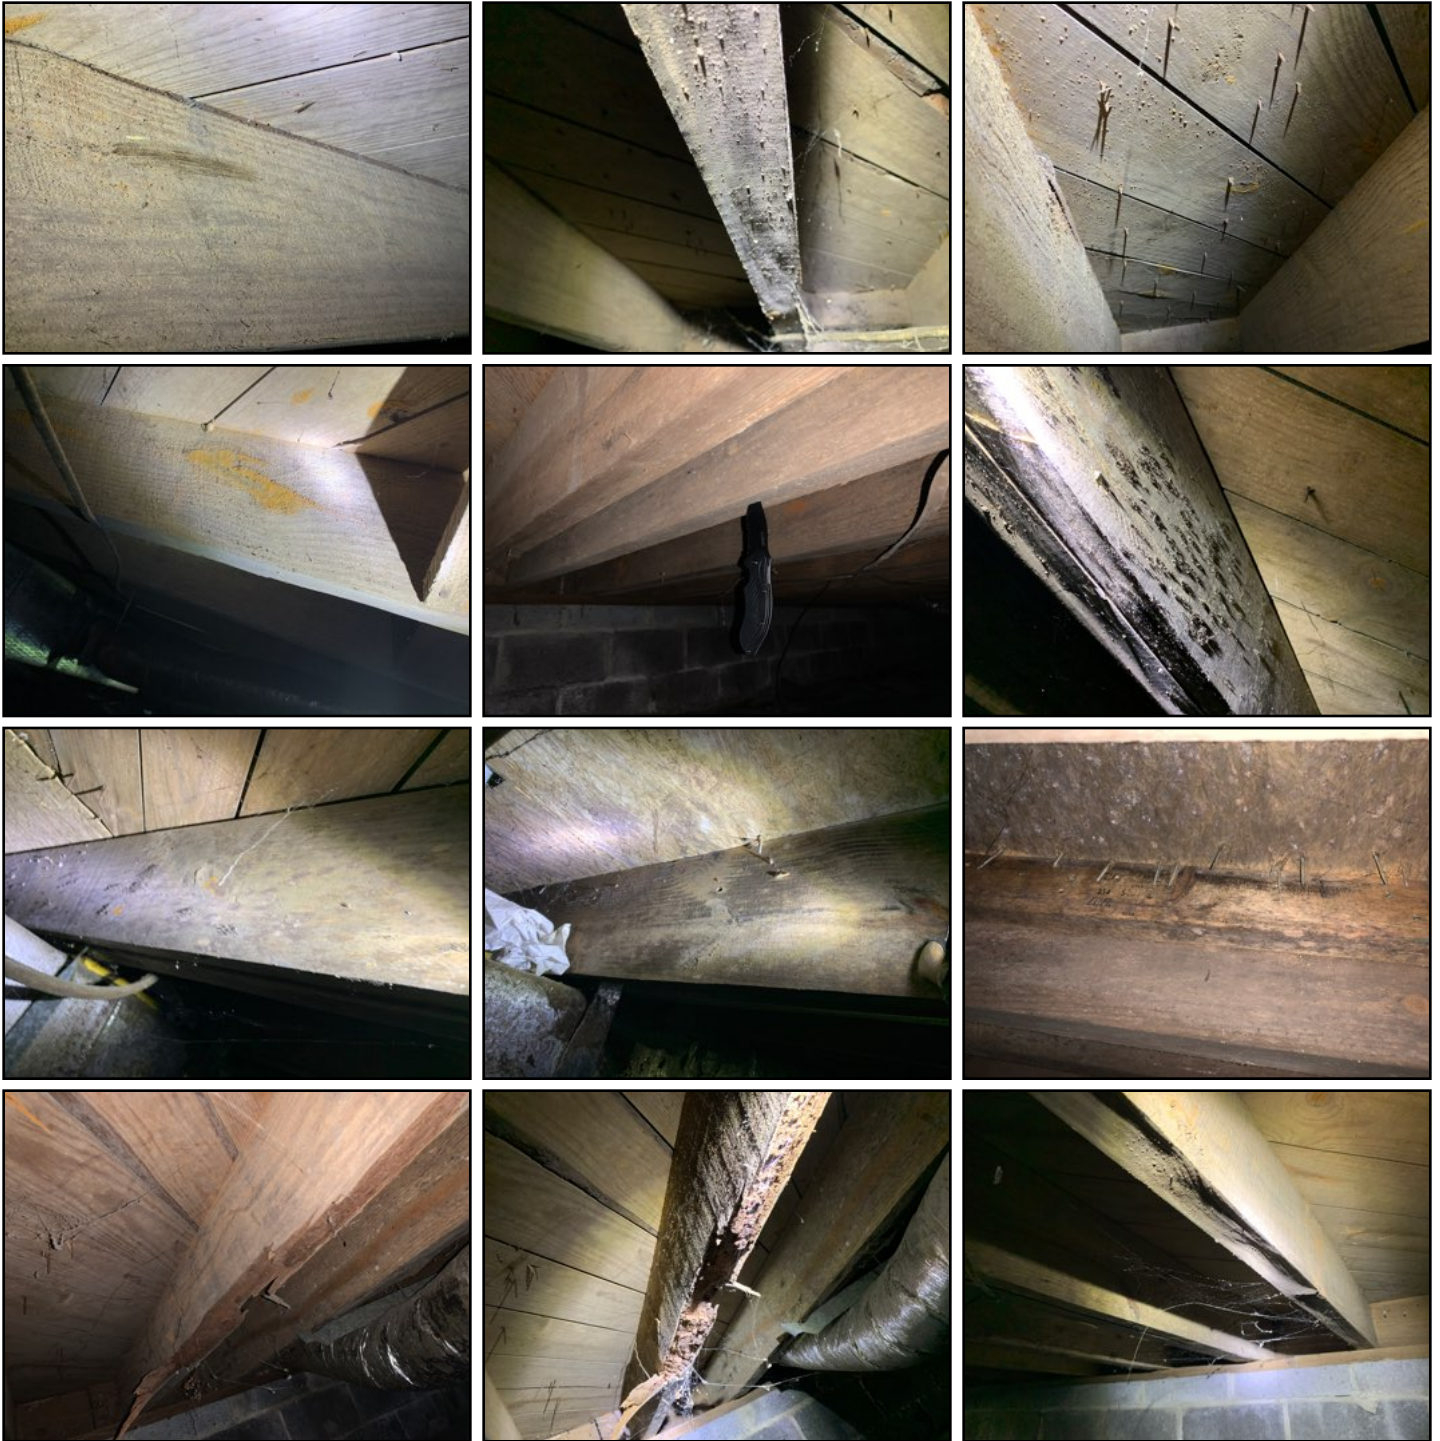
Microbial growth consistent with mold was observed on the wooden floor structure in the crawlspace. In addition, there were many rotted or cracked joists observed, primarily in the front portion of the crawlspace. These conditions indicate an ongoing moisture issue in the crawlspace. Some of the joists had been sistered, but those joists were covered in fungus. I recommend discussing options and costs for correction of the moisture, and repair of the joists with several qualified contractors. (\$2500-\$5000+)

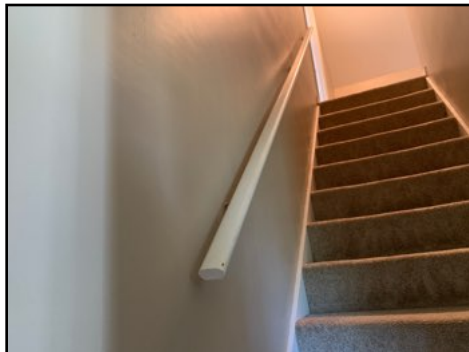
The handrail to the second floor did not return to the wall. This is required by modern standards to prevent snagging on bags or loose clothing. You may wish to have this corrected.
