# PROPERTY INSPECTION REPORT

**KBM Home Inspect LLC**  
**License #: 3380000867**  
**Inspector: Logan Melton**

Property Address:  
1600 Pennsylvania Ave, Richmond, Australia, 12345

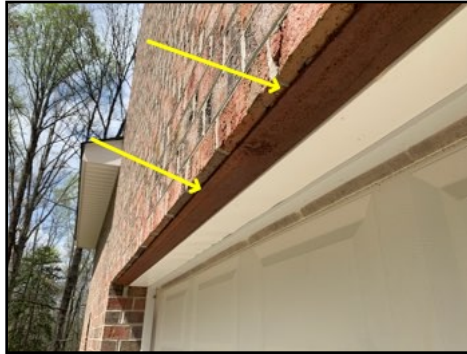
The lintels around the home were rusted. Lintels are steel supports above the windows and doors. Rusting lintels can damage the brick siding. I recommend having the lintels treated and sealed.

Rusted Lintel (Representative Photo)

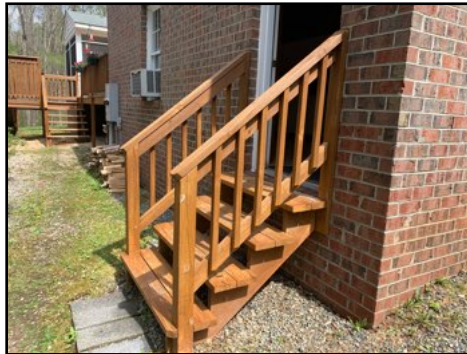
There was no landing observed at the exterior rear steps at the garage workshop. This is a safety concern. The landing should be at least the size of the door opening, and at least 36" in the direction of travel. I recommend repair by a qualified contractor. (\$250-\$500+)

No Landing Observed

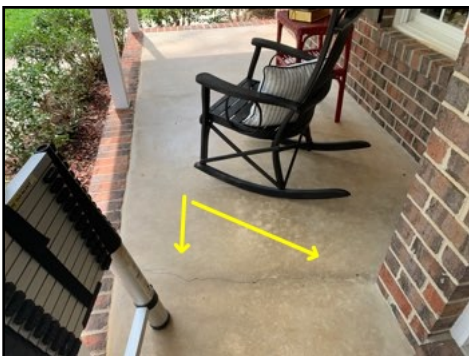
A typical crack was observed at the concrete pad at the front porch. It would be prudent to have the crack sealed to prevent further damage through freeze/thaw cycles.

Typical Crack at Front Porch

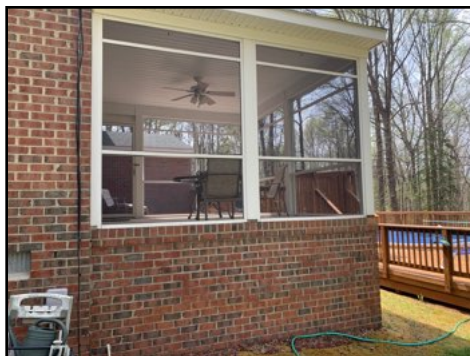
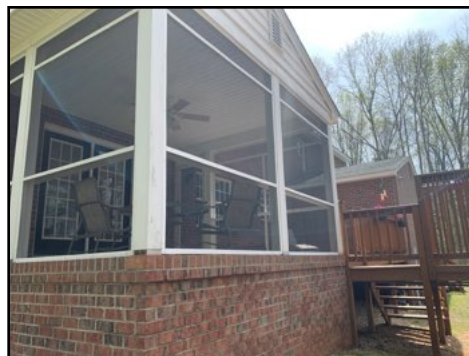
The rear covered porch was high enough from grade level to require a guardrail, but none was observed. This is a safety concern. I recommend repair by a qualified contractor. (\$150-\$300+)

No Guardrail

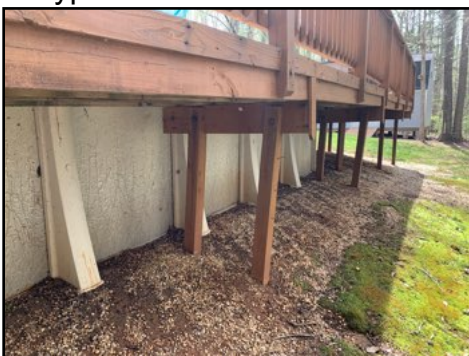
There were several posts at the rear side of the decking at the pool that were leaning towards the back of the property. This is likely caused by inadequate footings. I recommend having this evaluated and repaired as needed by a qualified contractor. (Cost TBD by Contractor)

Leaning Deck Posts

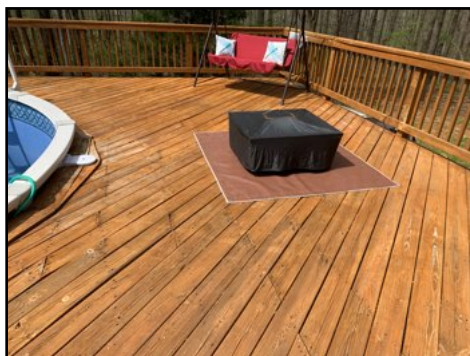
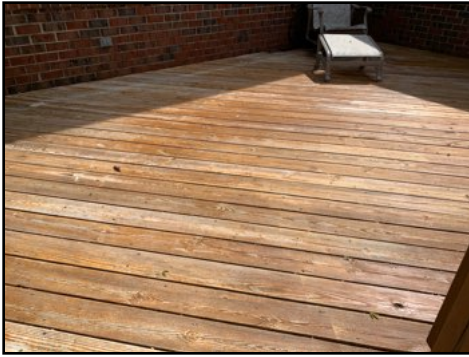
The rear deck was lacking regular maintenance. I recommend driving down any nail pops, replacing any warped/rotted boards, and sealing the deck. This is a normal part of home maintenance.

Deck in Need of Maintenance

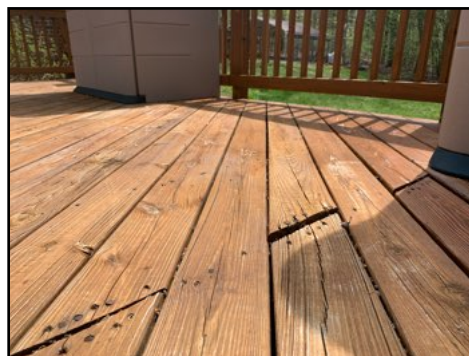
Warping Boards

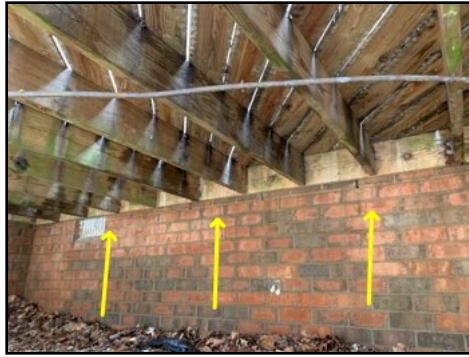
No flashing was observed between the ledger board at the . Flashing protects the adjacent structure from moisture intrusion. I recommend repair by a qualified contractor. (\$500+)

No Ledger Flashing Observed

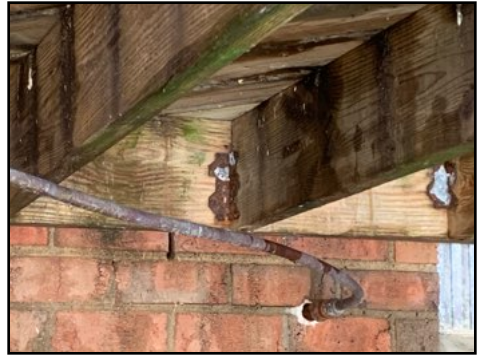
There were many rusted joist hangers observed at the rear deck, closer to the home. I recommend repair by a qualified contractor. (\$100-\$200+)

Rusted Joist Hanger  
(Representative Photo)

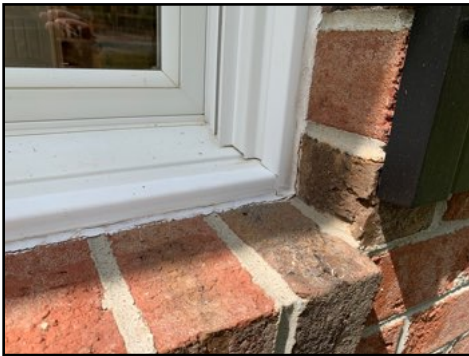
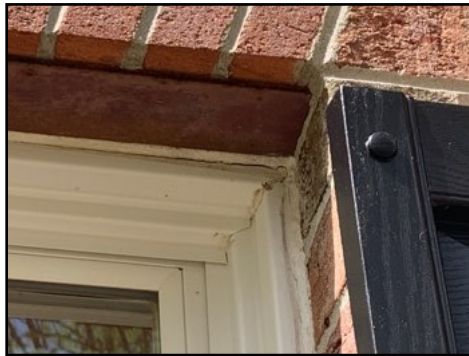
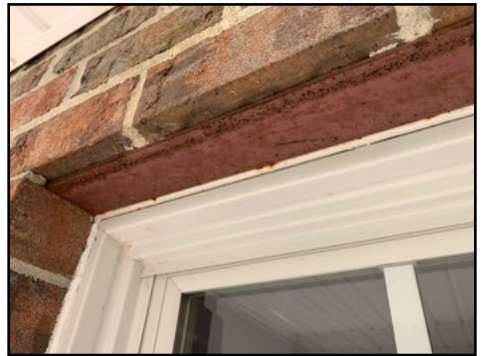
There was some dry and cracking caulk observed in several areas around the exterior of the home. Caulk prevents moisture and wind intrusion. I recommend replacing any cracked/missing caulk. This is a normal part of home maintenance.

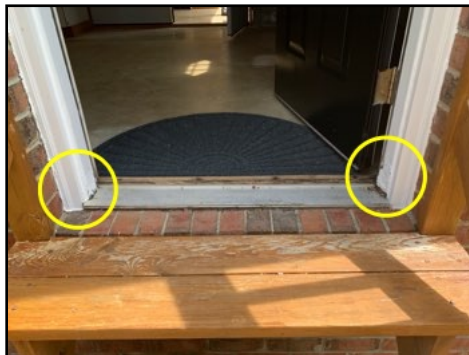
Rot was observed at the door trim at the rear door, at the workshop. I recommend repair by a qualified contractor. (\$75+)

Rot Observed Here

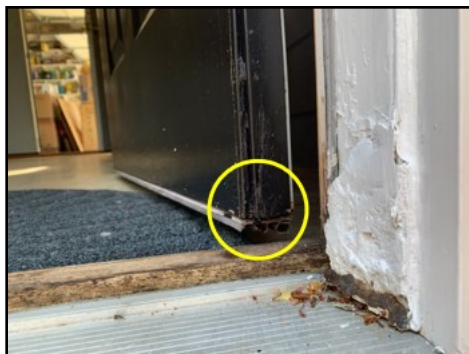
Rot was observed at the bottom corner of the rear door, at the workshop. I recommend repair by a qualified contractor. (\$75+)

Rot Observed Here

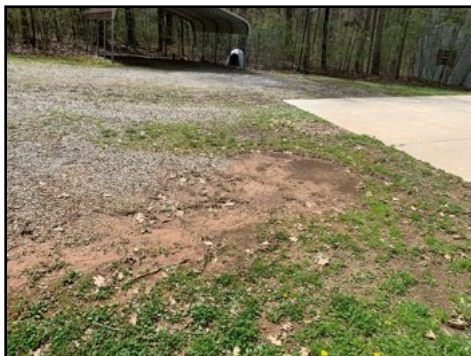
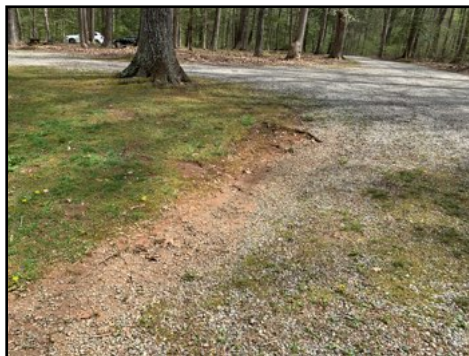
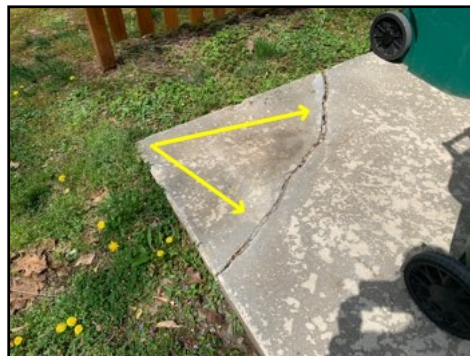
There were some areas in the gravel driveway that were missing gravel. You may wish to add gravel to these areas to prevent ponding water.

There was a crack at one of the corners at the concrete portion of the driveway. Have repaired as desired.

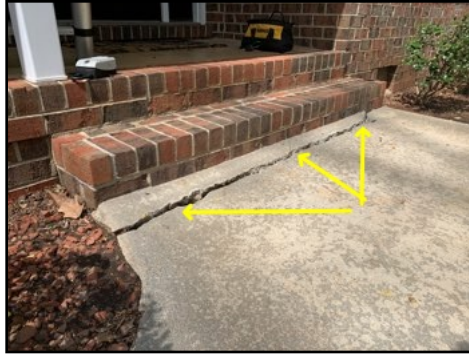
The front walkway had settled, near the stairs. Although still functional as a walkway, you may wish to have this repaired.

Some Settlement Observed (Front Walkway)

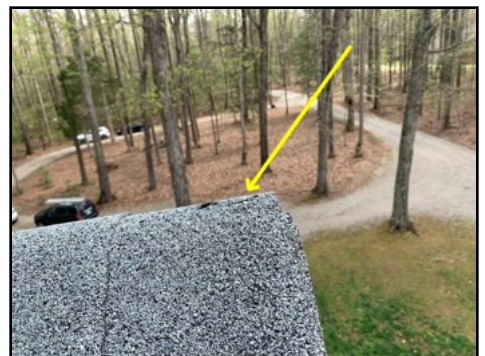
Torn shingles were observed at the ends of several of the ridges. I recommend repair by a qualified roofer. (\$250-\$500+)

Torn Shingle at Upper Ridge

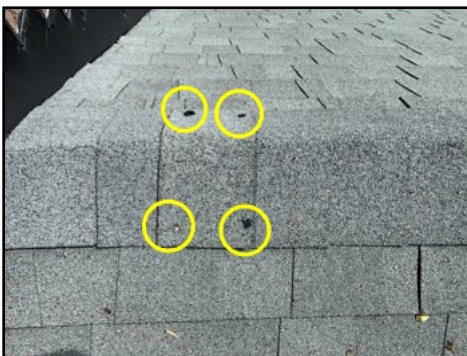
There was worn sealant observed at the nail heads at the ridge caps. I recommend having the nails re-sealed.

Worn Sealant at Nail Heads  
(Representative Photo)

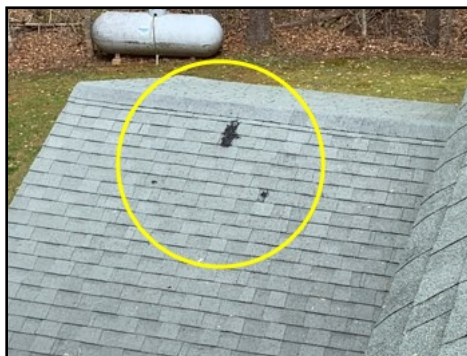
FYI: There was a tar patch observed at the roof above the rear covered porch. It appeared to be from the removal of a satellite dish. The tar here will need to be re-applied periodically.

Tar Repair Observed

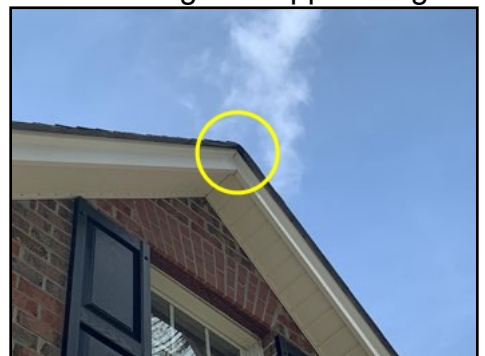
Torn Shingle Observed Here

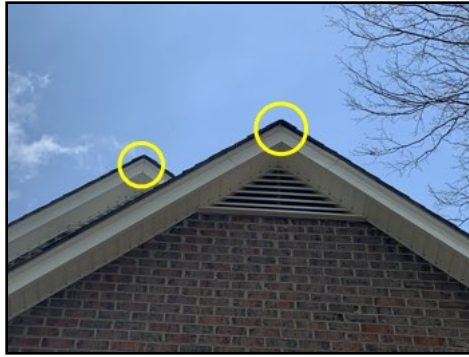
Torn Shingles Observed Here

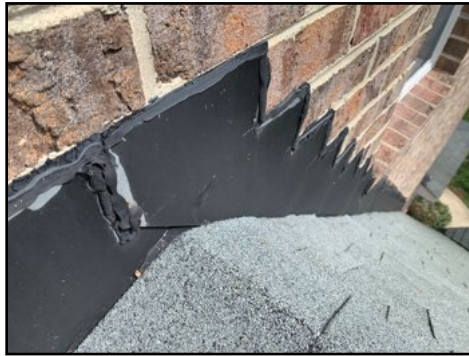
Worn sealant was observed at much of the counter flashing. I recommend having the sealant re-applied. This will need to be done periodically.

Worn Sealant at Counter Flashing (Representative Photo)

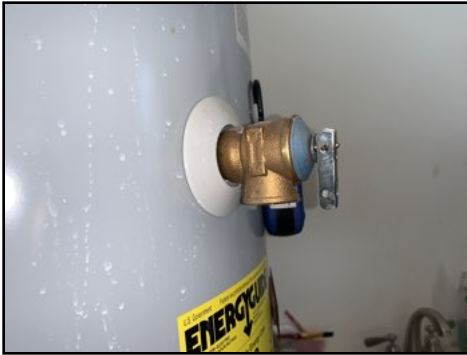
There was no discharge pipe observed at the temperature pressure relief valve (TPRV) at the water heater. This is a safety concern. I recommend repair by a qualified plumber. (\$100+)

Missing Discharge Pipe (Water Heater TPRV)

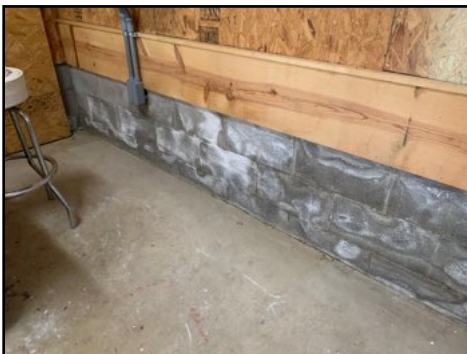
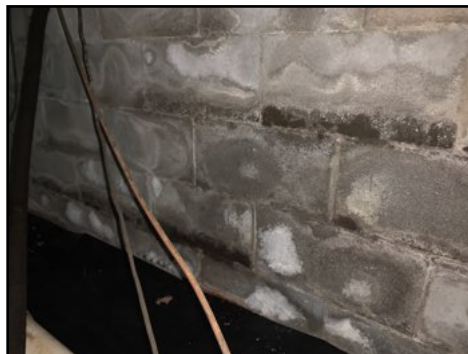
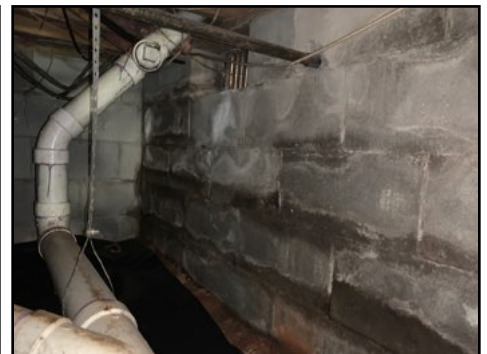
Efflorescence was observed on the left wall in the garage workshop, and along the adjacent rear wall in the crawlspace. This appeared to be related to the lack of flashing at the rear deck ledger board. I recommend having these areas evaluated and necessary repairs made by a qualified contractor. (\$400-\$800+)
