PROPERTY INSPECTION REPORT

KBM Home Inspect LLC
License #: 3380000867
Inspector: Logan Melton

Champ de Mars, 5 Av. Anatole France, 75007, Paris, France

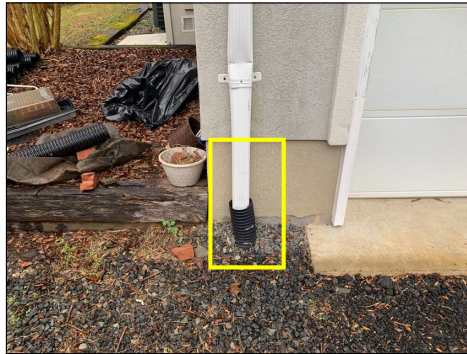
Downspout Terminating Below Grade (Representative Photo)

A few of the downspouts terminated too close to the foundation. This can concentrate roof drainage around the foundation. I recommend extending the downspouts at least six feet from the foundation.

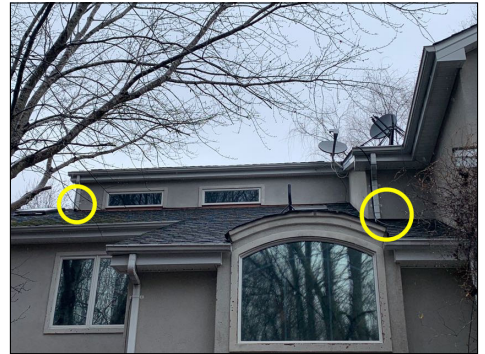
Downspouts Terminating Above Roof

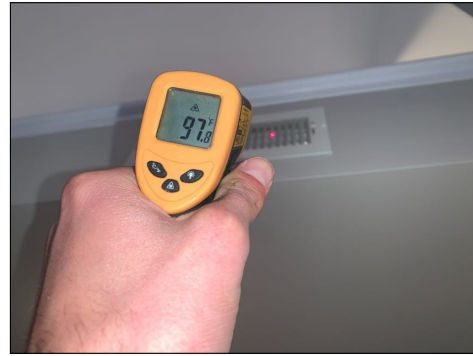
The heating system(s) were functioning properly at the time of inspection. Routine maintenance and regular cleaning will extend the life of the system(s).

Second Floor Heating System Functional (97.8)

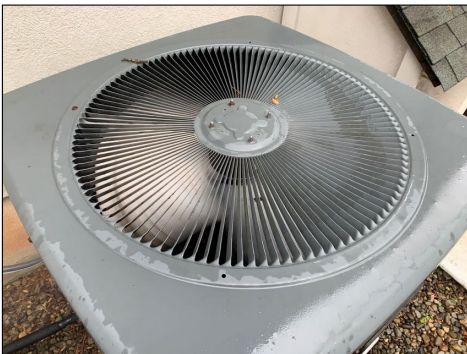
The exterior temperature was too cold to operate the cooling systems in cooling mode for an extended period of time. The inspection was limited to setting the thermostats to cooling mode, and confirming proper communication and start-up. It is possible that defects exist that were not observed.

First Floor & Basement AC Operating in Cooling Mode

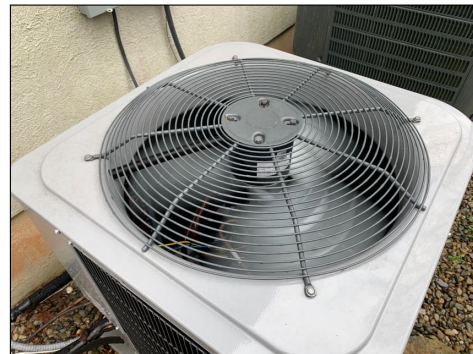
Second Floor Heat Pump Operating in Cooling Mode

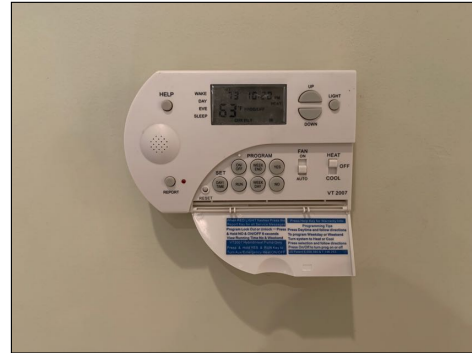
General Photo (Second Floor)

There was no emergency heat setting at the thermostat for the second floor HVAC system. Because of this, I was unable to isolate and test the emergency heat. I recommend having a qualified HVAC technician replace the thermostat with an emergency heat setting, and confirming the proper operation of the second floor emergency heat. (\$200-\$400+)
