PROPERTY INSPECTION REPORT

KBM Home Inspect LLC
License #: 3380000867
Inspector: Logan Melton

Champ de Mars, 5 Av. Anatole France, 75007, Paris, France

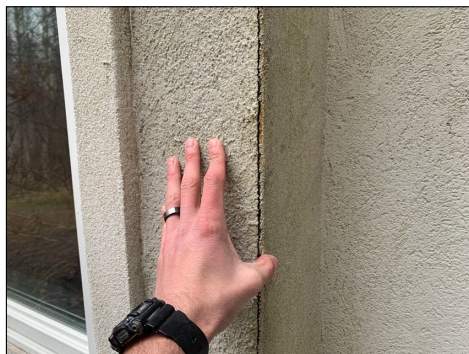
Damage to Siding Observed Around These Windows (Rear of Home)

At Rear Windows

Damage and evidence of moisture intrusion was observed in several locations around the exterior of the home (See Photos for Locations). Affected areas will be prone to moisture intrusion and subsequent damage. I recommend evaluation and repair as needed by a qualified contractor that is familiar with the EIFS system. (\$2500-\$5000+)

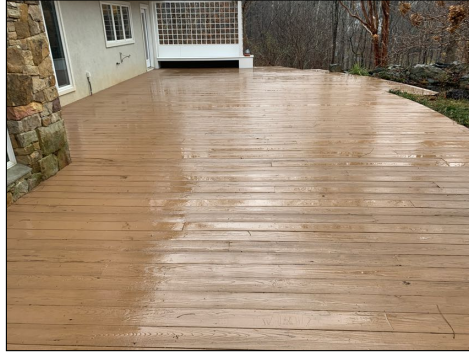
The deck was low to the ground, and I was unable to inspect under the deck. It is possible that defects exist that were not observed.

General Photo

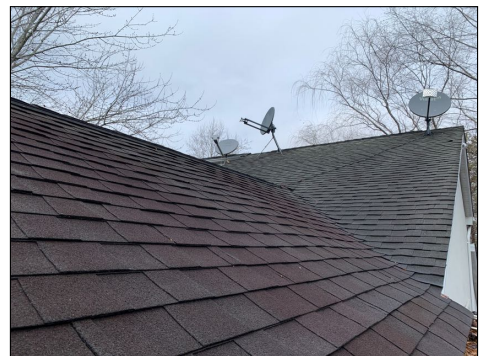
General Photo

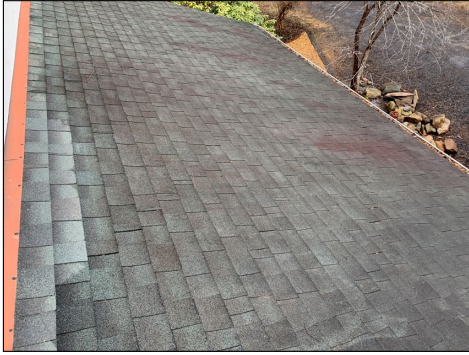
General Photo

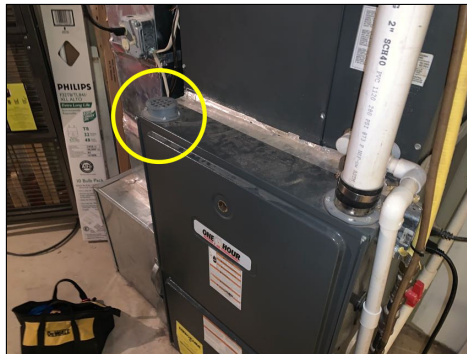
There was no elbow or gooseneck at the **combustion air** intake for the first floor and basement gas furnace. Without one, the intake can become blocked. It would be prudent to have this corrected.

No Elbow or Gooseneck

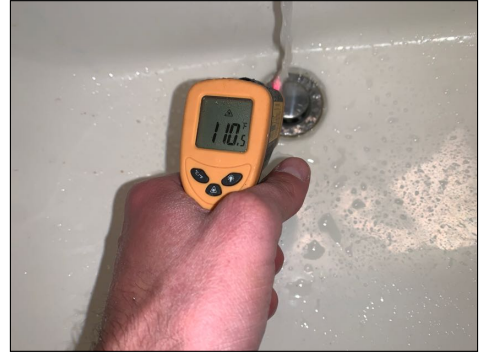
Hot Water Temperature (110.5)

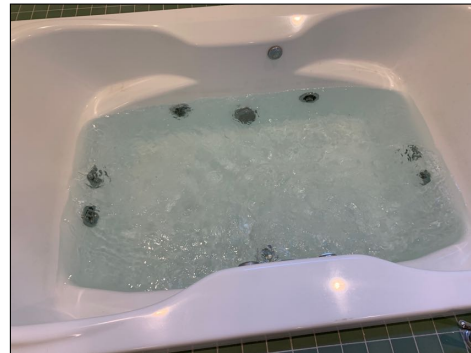
Jacuzzi Tub Functional

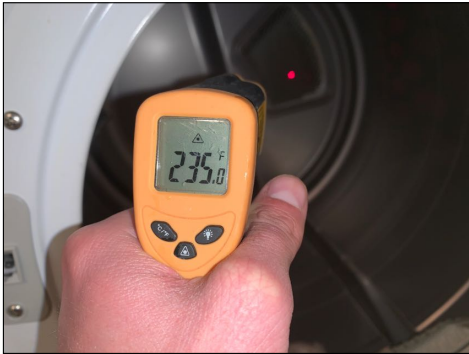
Dryer Functional

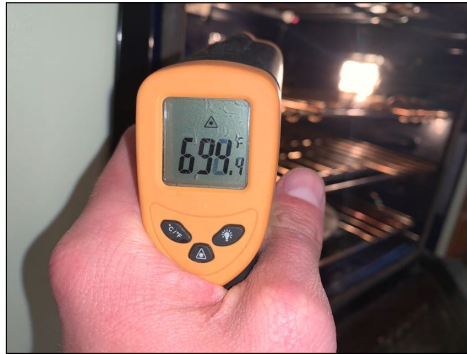
Oven Functional

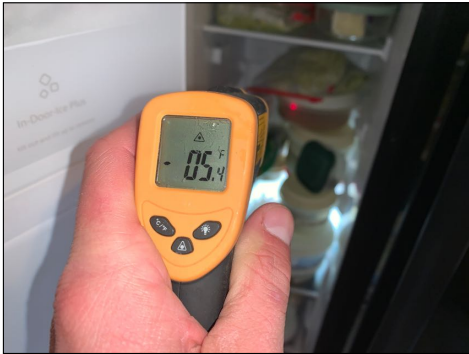
Freezer Functional

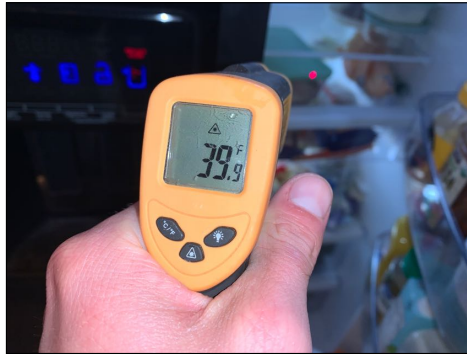
Refrigerator Functional

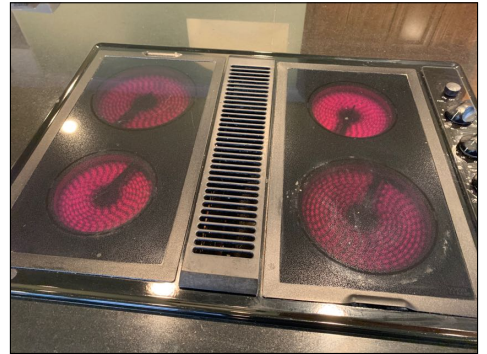
Range Functional

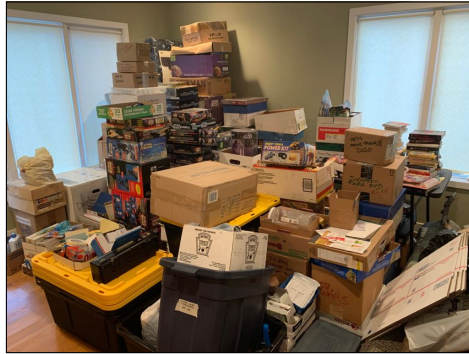
Some rooms, and the garage were filled with personal storage. This limits the inspection. It is possible that defects exist that were not observed.

Personal Storage Observed
